Manhole Inspection Summary

Manhole # S07GG2001MH

Location Address: **6216 LINCOLN AVE**

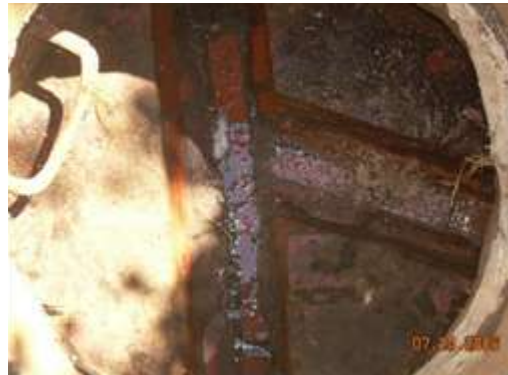
Top View

Corroded steps. Evidence of surcharge - Bench debris. Channel debris.

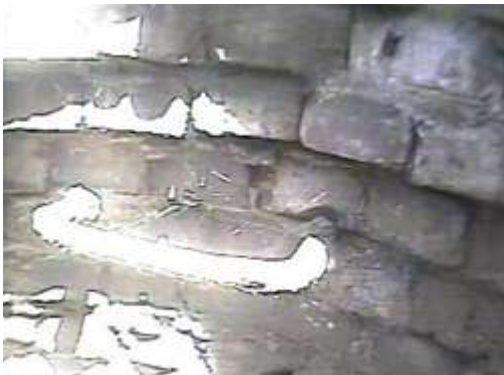
Defect

Corbel and Barrel deterioration and infiltration.

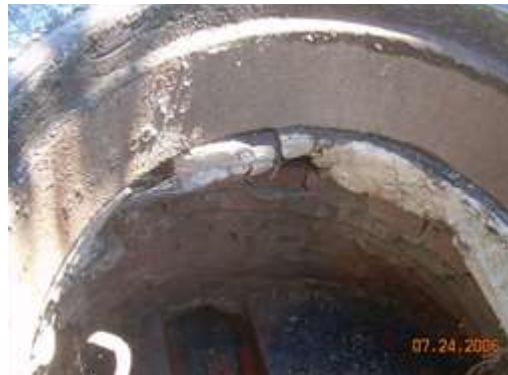
Defect

Frame leaks. Adjustment deterioration, loose brick and infiltration. Corbel and Barrel infiltration.

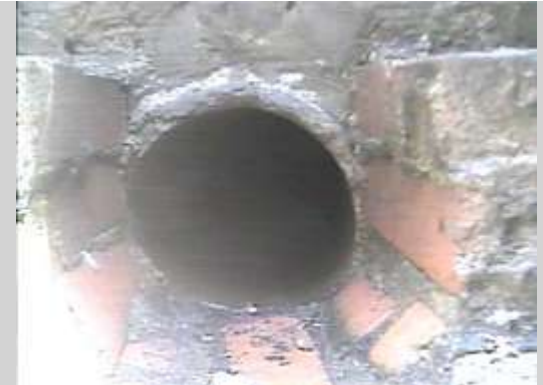
8 in. Circular Gravity Sewer Pipe Out @ 12 O'Clock

Pipe Material: **Clay** ☐ Pipe Lined

Invert Depth: **3.85** (ft.) Flow Characteristics: **Slow**

Infiltration: **None** Pipe Seal Cond: **Unknown**

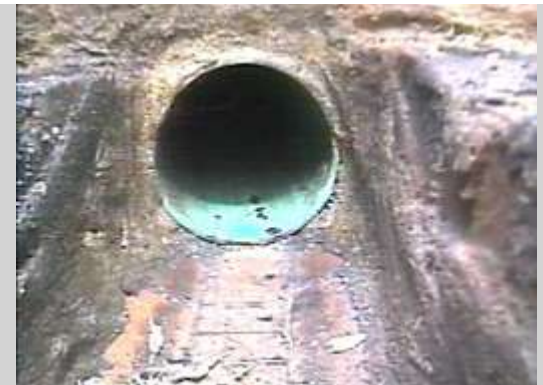
6 in. Circular Gravity Sewer Pipe In @ 3 O'Clock

Pipe Material: **PVC** ☐ Pipe Lined

Invert Depth: **3.61** (ft.) Flow Characteristics: **None**

Infiltration: **None** Pipe Seal Cond: **Unknown**

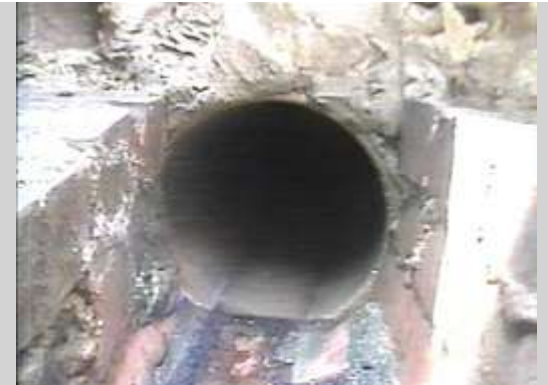
8 in. Circular Gravity Sewer

Channel deterioration.

Infiltration: **Evidence**
